VEHICLE CRASH TESTS OF THE TYPE 70  
BRIDGE RAIL

FINAL REPORT # FHWA/CA/ESC-98-06

STATE OF CALIFORNIA  
**DEPARTMENT OF TRANSPORTATION**  
DIVISION OF NEW TECHNOLOGY,  
MATERIALS AND RESEARCH

<b>16. ABSTRACT</b>  <p>A bridge rail Type 70 was built and tested in accordance with NCHRP Report 350. The Type 70 bridge rail is an 810 mm tall concrete barrier with a sloping face of 9.1 degrees from the vertical. The barrier tested was 22.9 m long and was constructed at the Caltrans Dynamic Test Facility in West Sacramento, California.</p> <p>A total of four crash tests were conducted under Report 350 test Level 4, one with an 820 kg car, two with 2000 kg pickup trucks and one with an 8000 kg van truck. Both the 820 kg and the 8000 kg tests were within the limits of the Report 350 guidelines. The first test of the 2000 kg pickup was unsuccessful due to a snagging problem with a floating hub on its extended rear axle. The problem with the first pickup led to a retest with a different pickup that did not have the extended floating rear hub. The second test was successful, with all results within the guidelines.</p> <p>The Type 70 is recommended for approval on California highways requirin

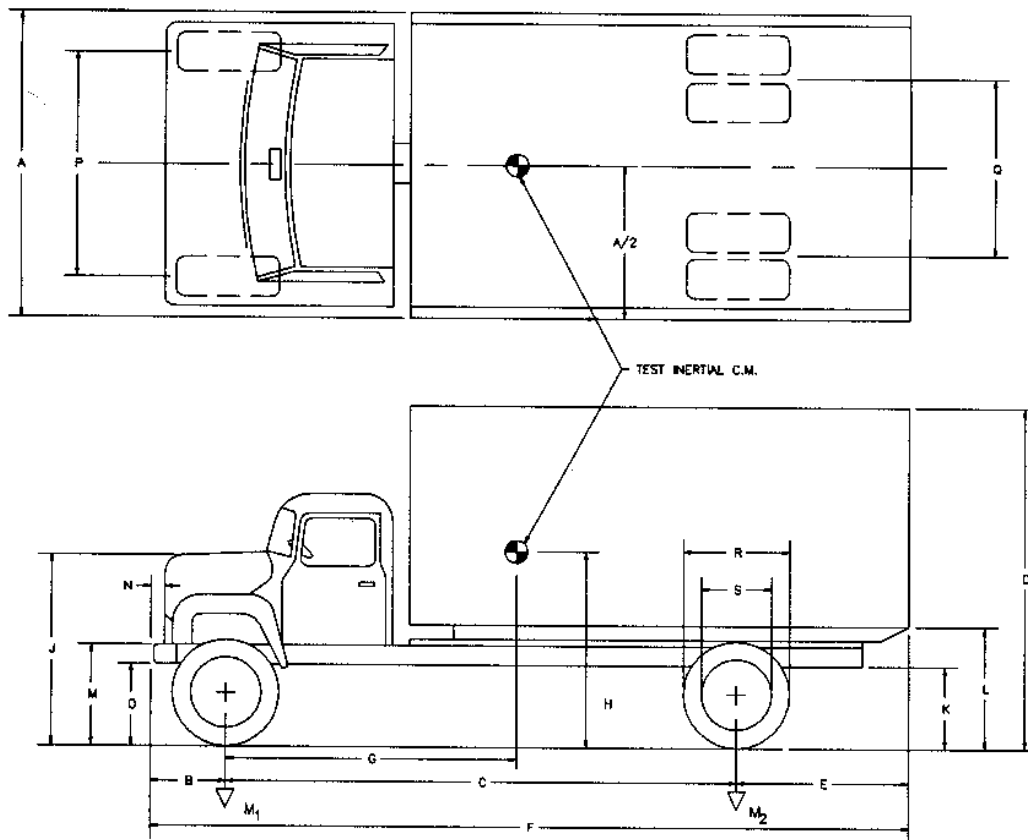
### GEOMETRY (cm)

A	243	D	345	G	363	K	73.5	N	10	Q	183
B	85	E	242	H		L	111	O	57	R	103
C	530	F	858	J	174	M	96	P	202	S	59

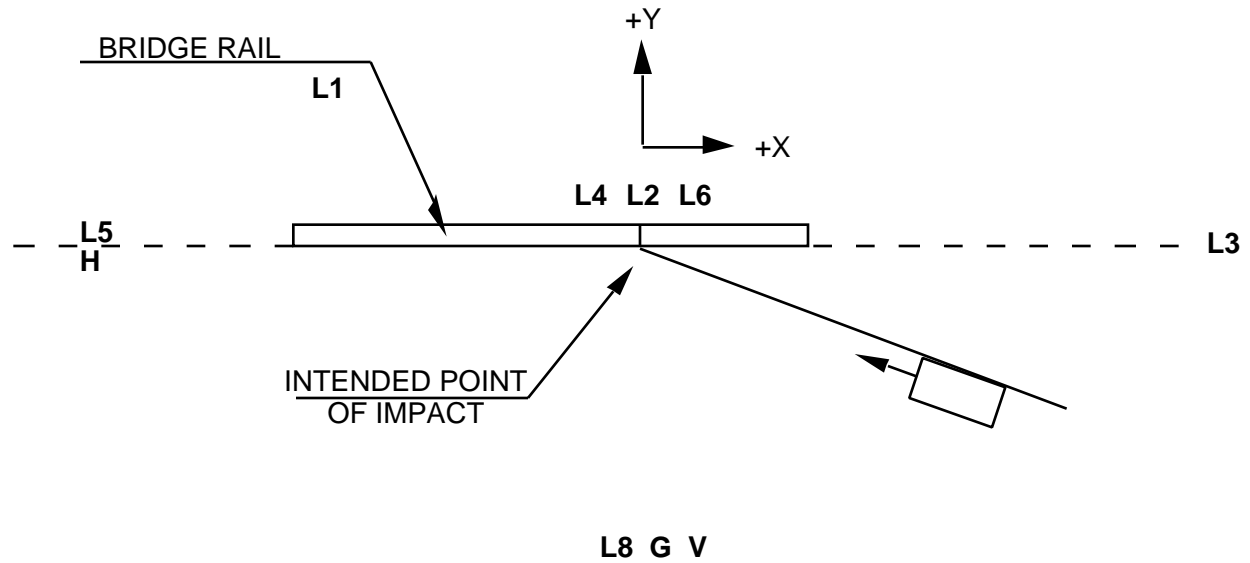
**Figure 7.1 - Camera Locations**

A video camera was turned on by hand and used for panning during the test. All other cameras were remotely triggered by switches on a console trailer near the impact area which contained eight 12-volt batteries. The test vehicle and test barrier were photographed before and after impact with a normal-speed movie camera, a black and white still camera and a color still camera. A film report of this project has been assembled using edited portions of the crash testing coverage.

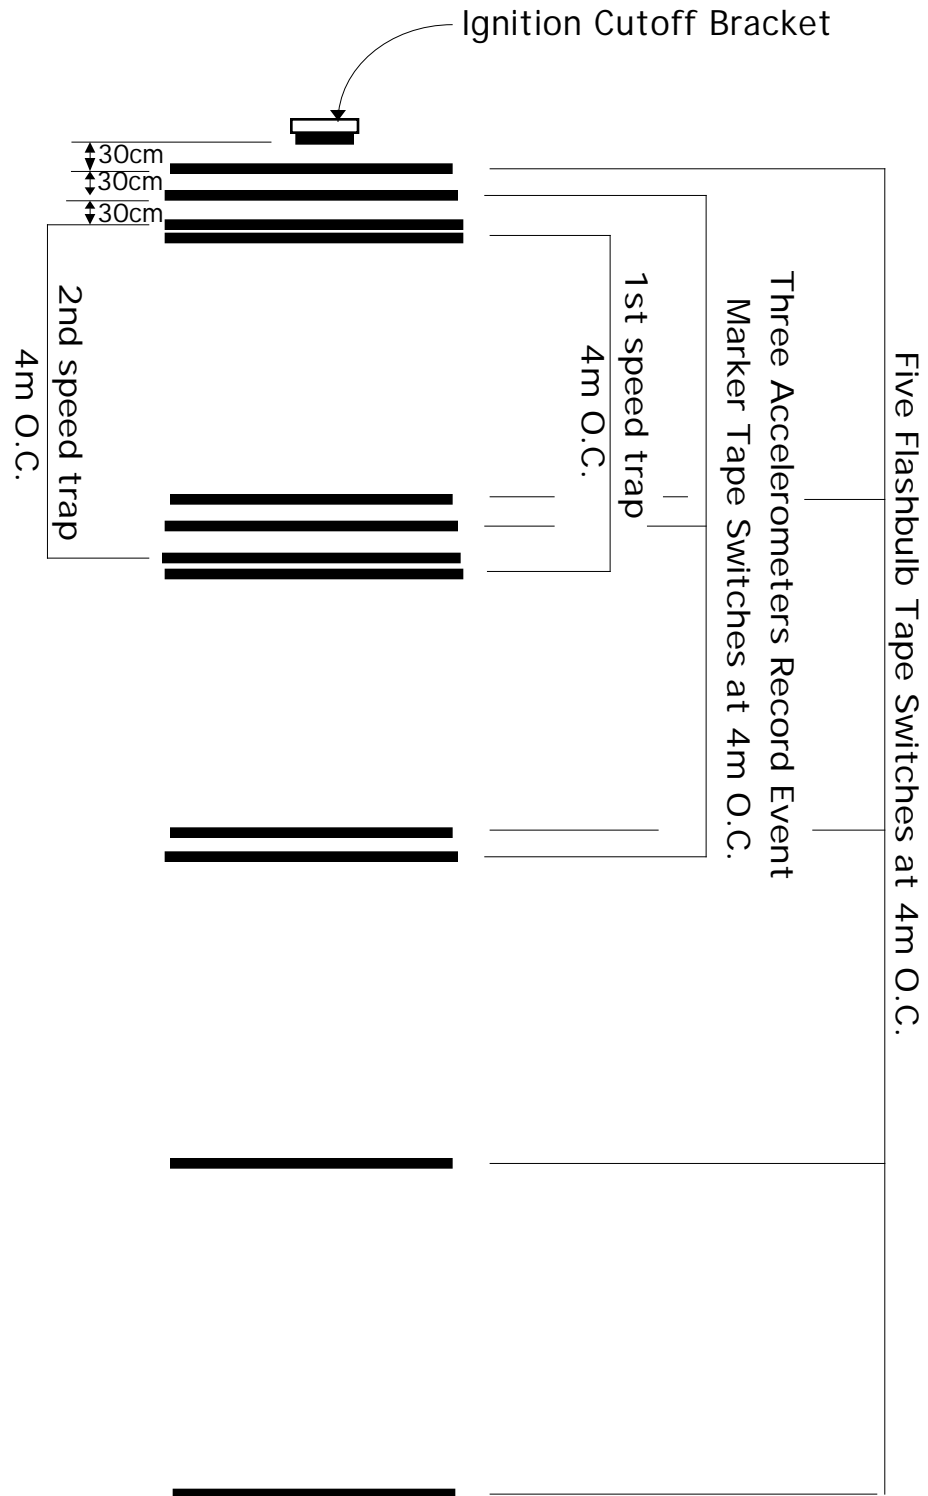
Figure 7.2 - Tape Switch Layout

3) Five tape switches, placed at 4 m intervals, were attached to the ground near the barrier and were perpendicular to the path of the test vehicle. Flash bulbs were activated sequentially when the tires of the test vehicle rolled over the tape switches. The flashbulb stand was placed in view of most of the cameras. The flashing bulbs were used to correlate the cameras with the impact events and to calculate the impact speed independent of the electronic speed trap. The tape switch layout is shown in Figure 7.2.

Three pressure-activated tape switches were placed on the ground in front of the test barrier (see Figure 7.2). They were spaced at carefully measured intervals of 4 m. When the test vehicle tires passed over them, the switches produced sequential impulses or "event blips" which were recorded concurrently with the accelerometer signals on the TDR, serving as "event markers". A tape switch on the front bumper of the vehicle closed at the instant of impact and accomplished two events: 1) an "event marker" was added to the recorded data, and 2) a flash bulbs mounted on the top of the vehicle was activated. A time cycle was recorded continuously on the TDR with a frequency of 500 cycles per second. The impact velocity of the vehicle could be determined from the tape switch impulses and timing cycles. Two other tape switches, connected to a speed trap, were placed 4 m apart just upstream of the test barrier specifically to establish the impact speed of the test vehicle. The tape switch layout for all tape switches is shown in Figure 7.2.

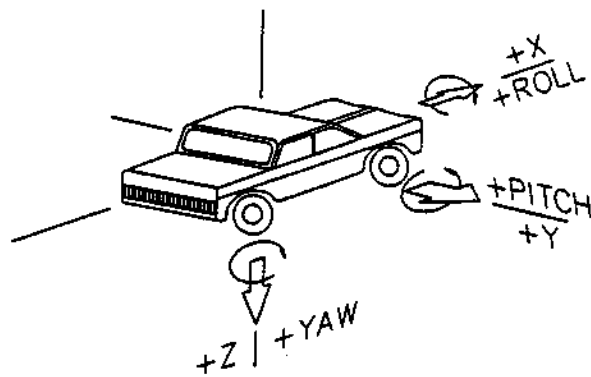
**Figure 7.3 - Vehicle Accelerometer Sign Convention**

TYPE	LOCATION	RANGE	ORIENTATION	TEST NUMBER
STATHAM	VEHICLE C.G.	100 G	LONGITUDINAL	ALL
STATHAM	VEHICLE C.G.	100 G	LATERAL	ALL
STATHAM	VEHICLE C.G.	50 G	VERTICAL	ALL
HUMPHREY	VEHICLE C.G.	180 DEG/SEC	ROLL	ALL
HUMPHREY	VEHICLE C.G.	90 DEG/SEC	PITCH	ALL
HUMPHREY	VEHICLE C.G.	180 DEG/SEC	YAW	ALL
ENDEVCO	VEHICLE C.G.	200 G	LONGITUDINAL	ALL
ENDEVCO	VEHICLE C.G.	200 G	LATERAL	ALL
ENDEVCO	VEHICLE C.G.	200 G	VERTICAL	ALL

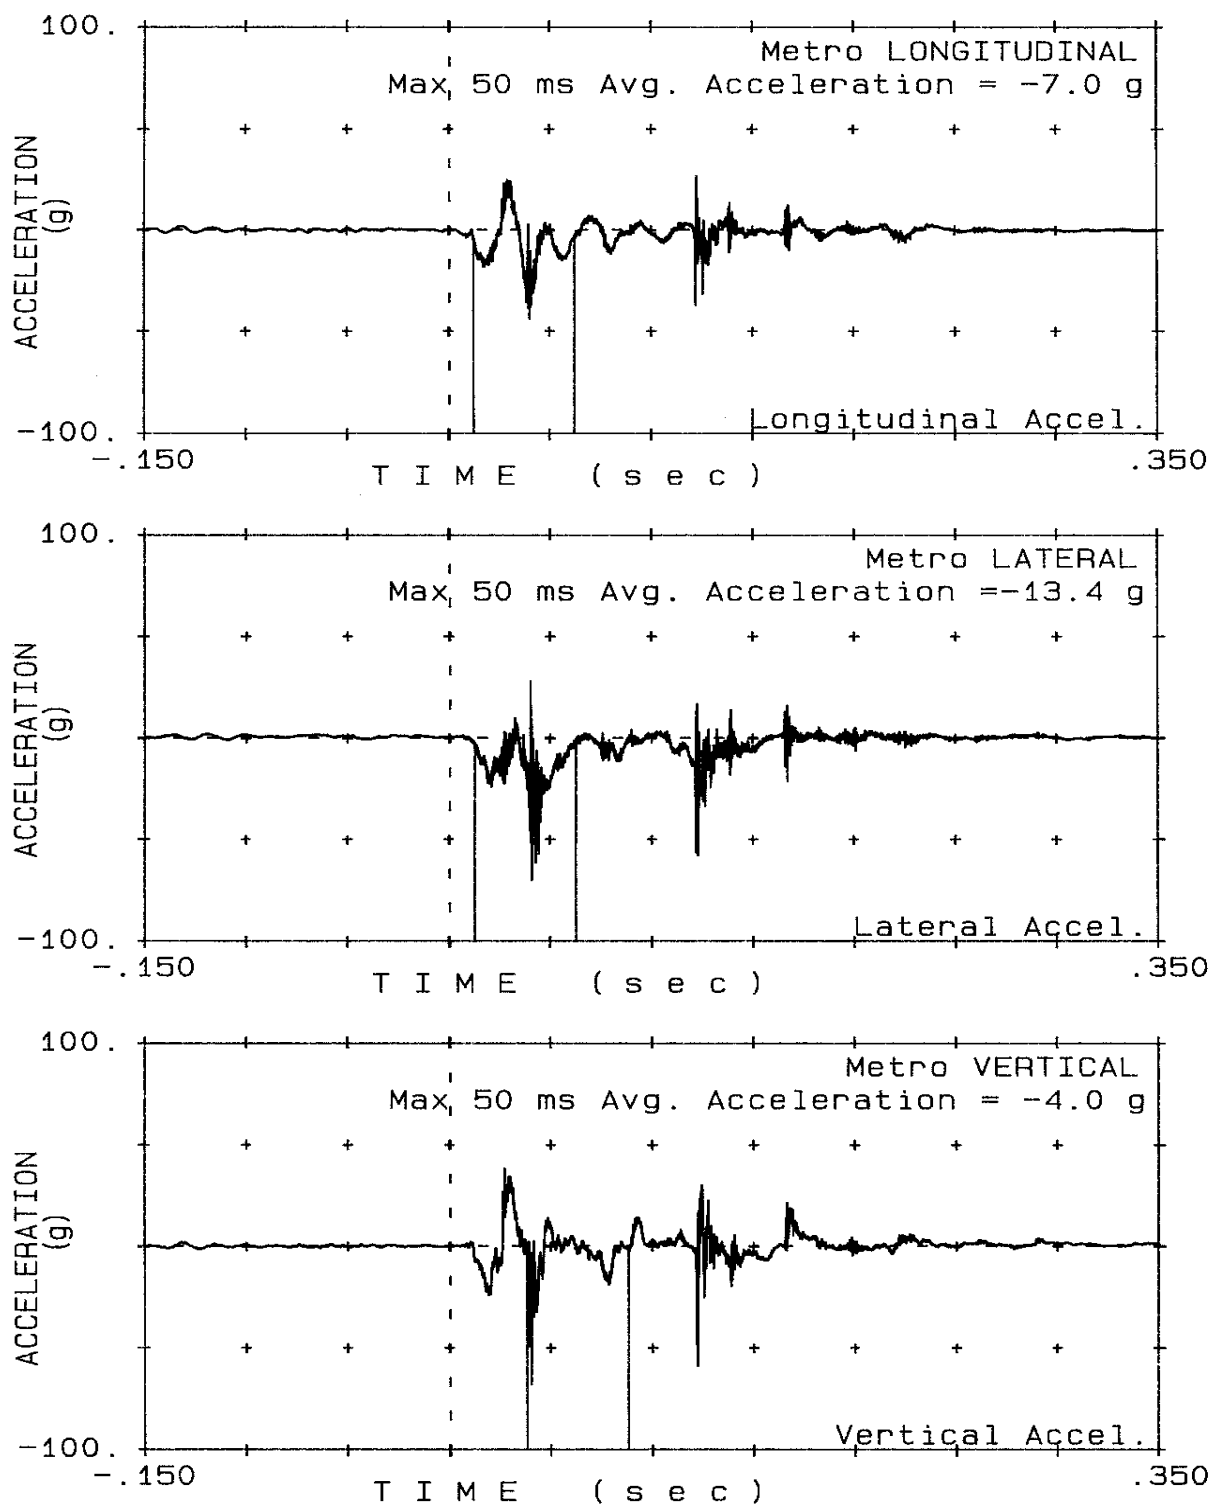
Test #511 Type 70 BR Date: 5/6/97

**Figure 7.4 - Test 511 Vehicle Accelerations -vs- Time**

The data curves are shown in Figure 7.4 through Figure 7.8 and include the accelerometer and rate gyro records from the test vehicles. They also show the longitudinal velocity and displacement versus time. These plots were needed to calculate the occupant impact velocity defined in NCHRP Report 350. All curves were calculated using software written by Pacific Instruments and modified by Caltrans.

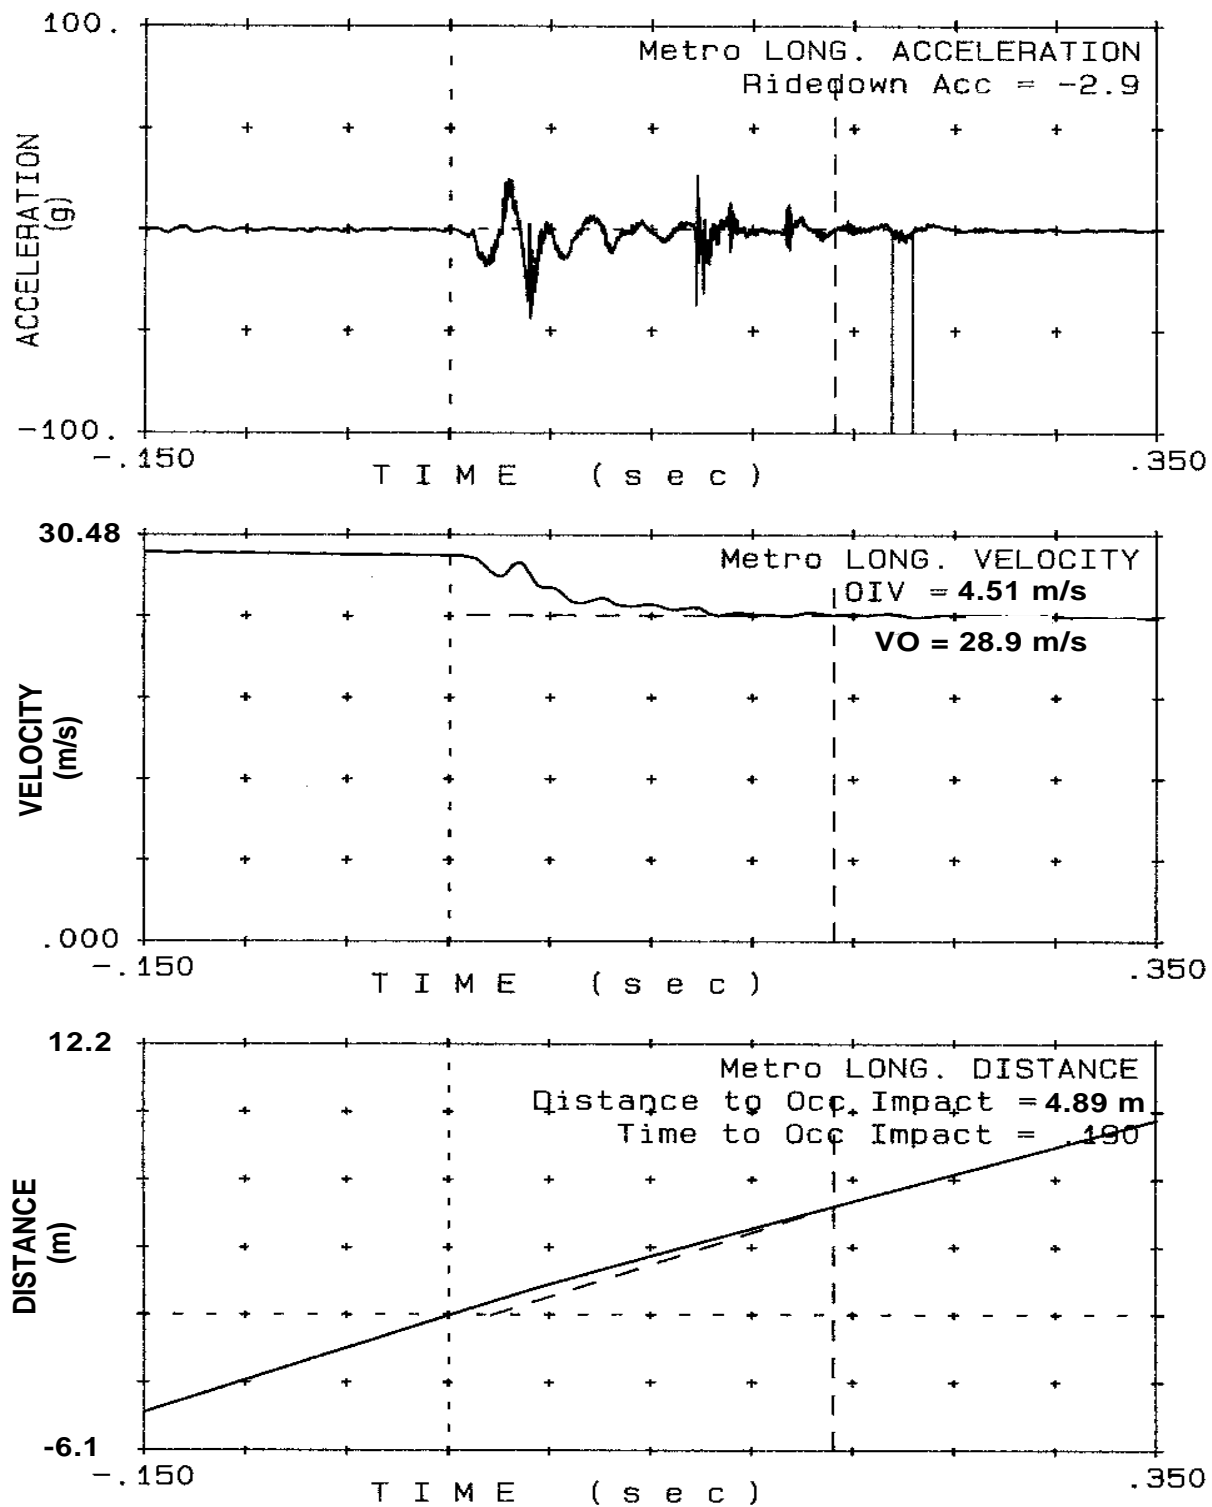
Test #511 Type 70 BR Date: 5/6/97

**Figure 7.5 - Test 511 Vehicle Longitudinal Acceleration, Velocity and Distance -vs- Time**

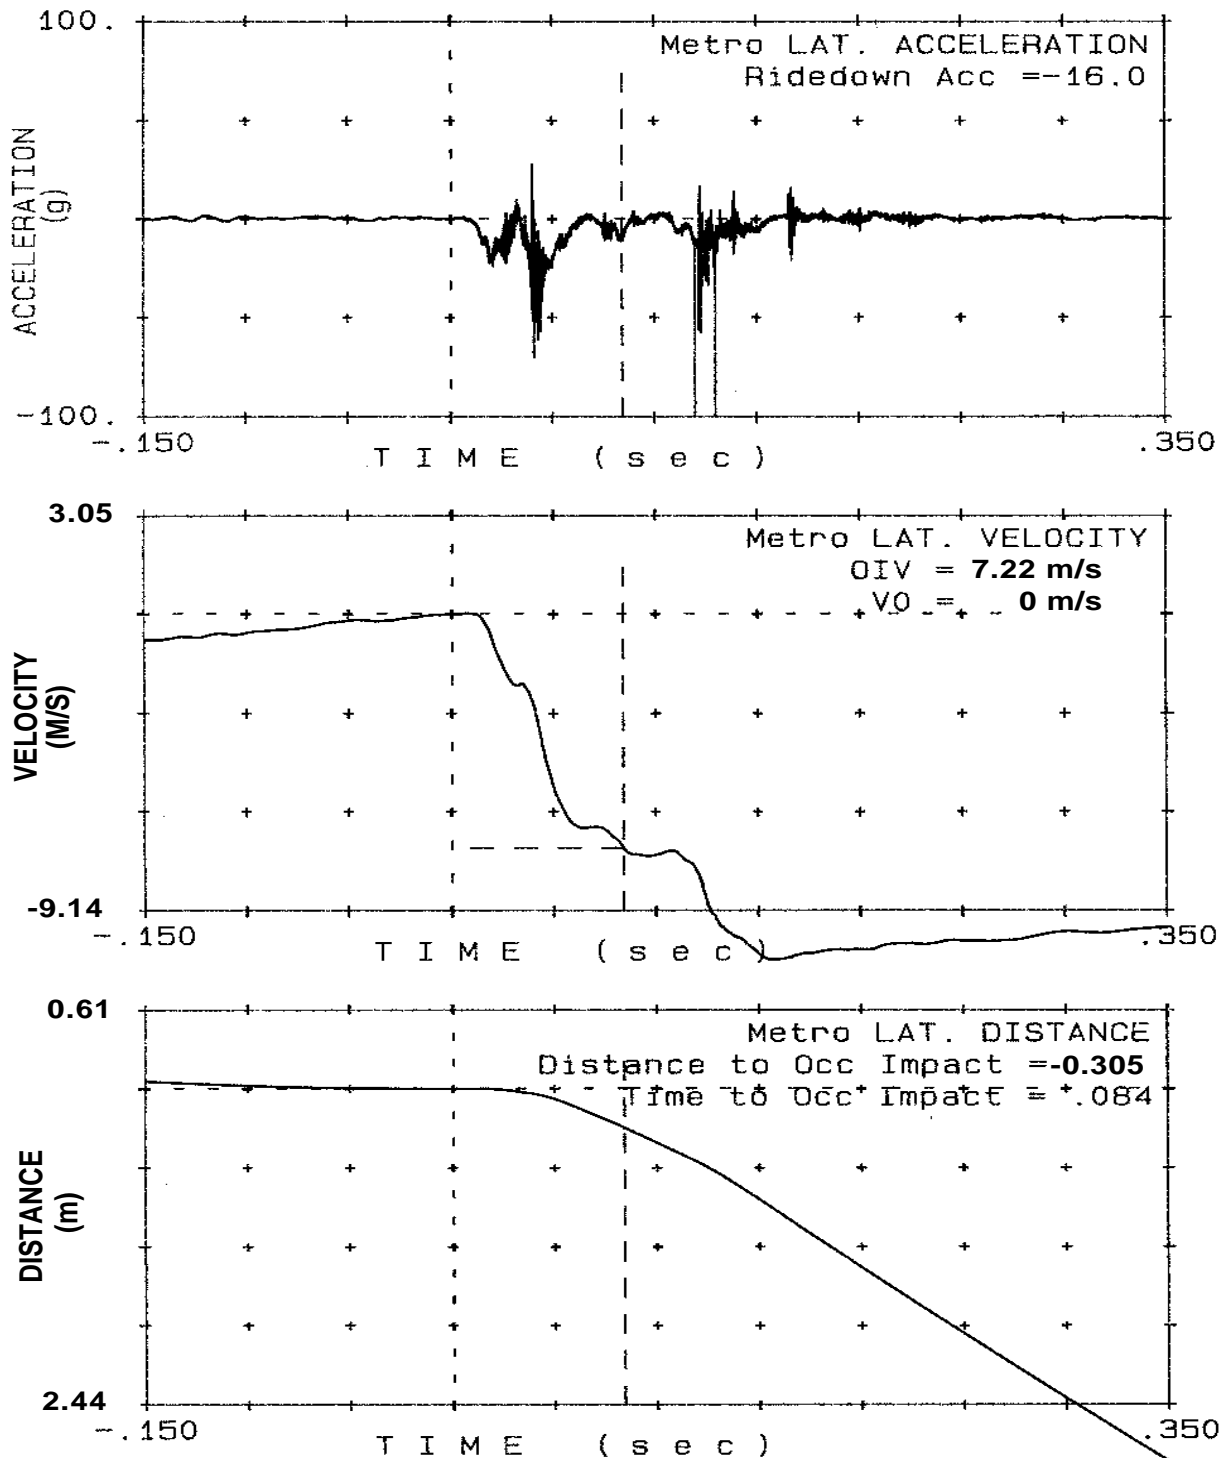
Test #511 Type 70 BR Date: 5/6/97

**Figure 7.6 - Test 511 Vehicle Lateral Acceleration, Velocity and Distance  
-vs- Time**

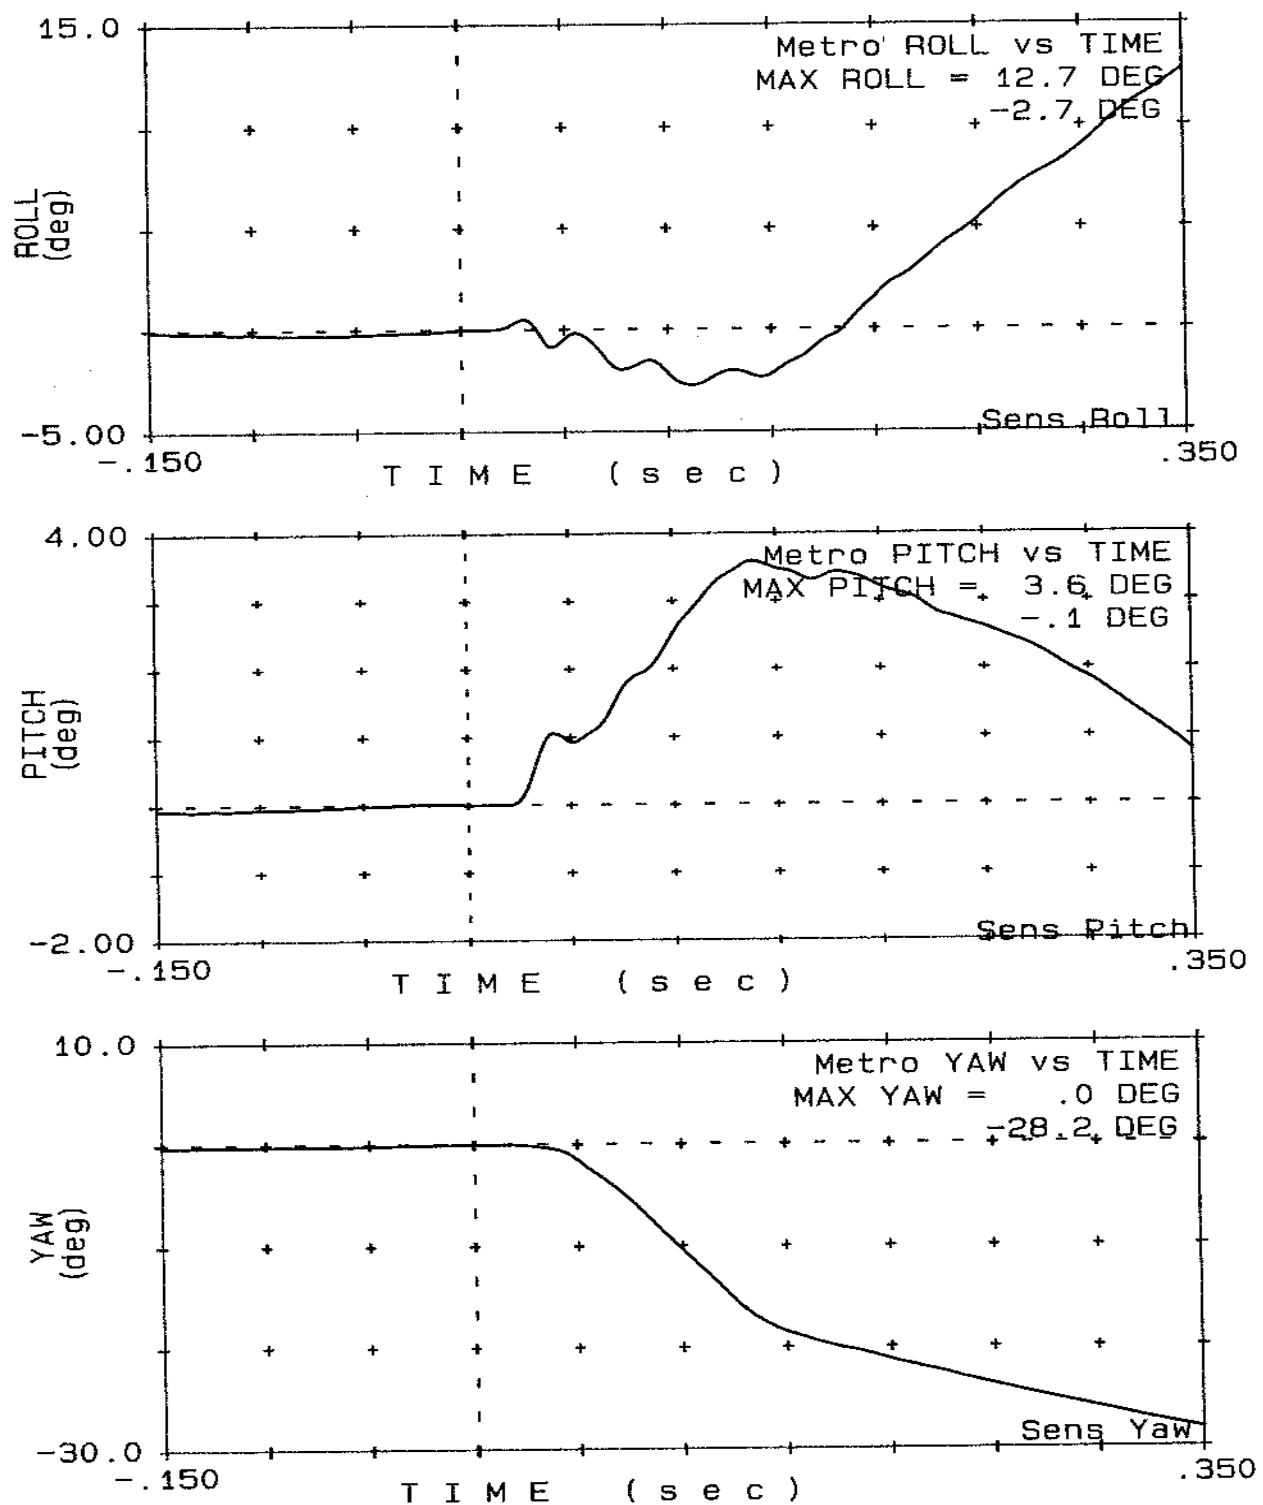
**Figure 7.7 - Test 511 Vehicle Roll, Pitch and Yaw -vs- Time**  
Test #511 Type 70 BR Date: 5/6/97

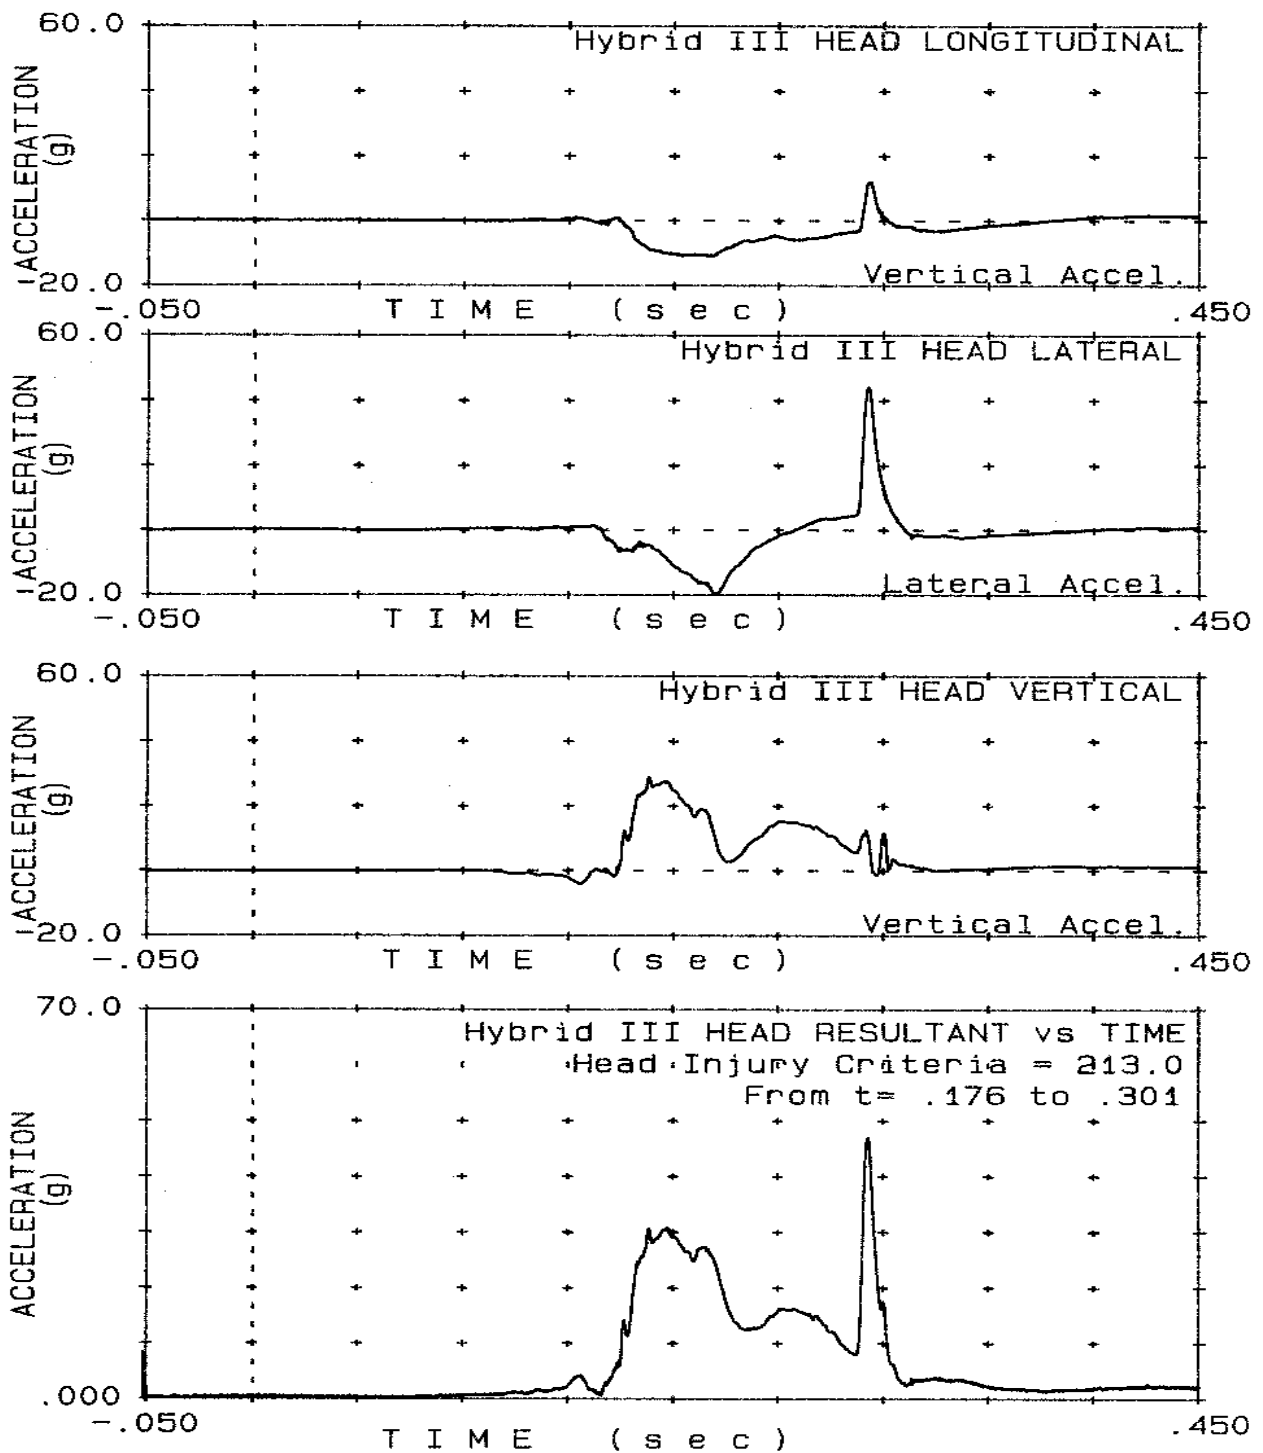
**Figure 7.8 - Test 511 Dummy Head Accelerations -vs- Time**  
Test #511 Type 70 BR Date: 5/6/97

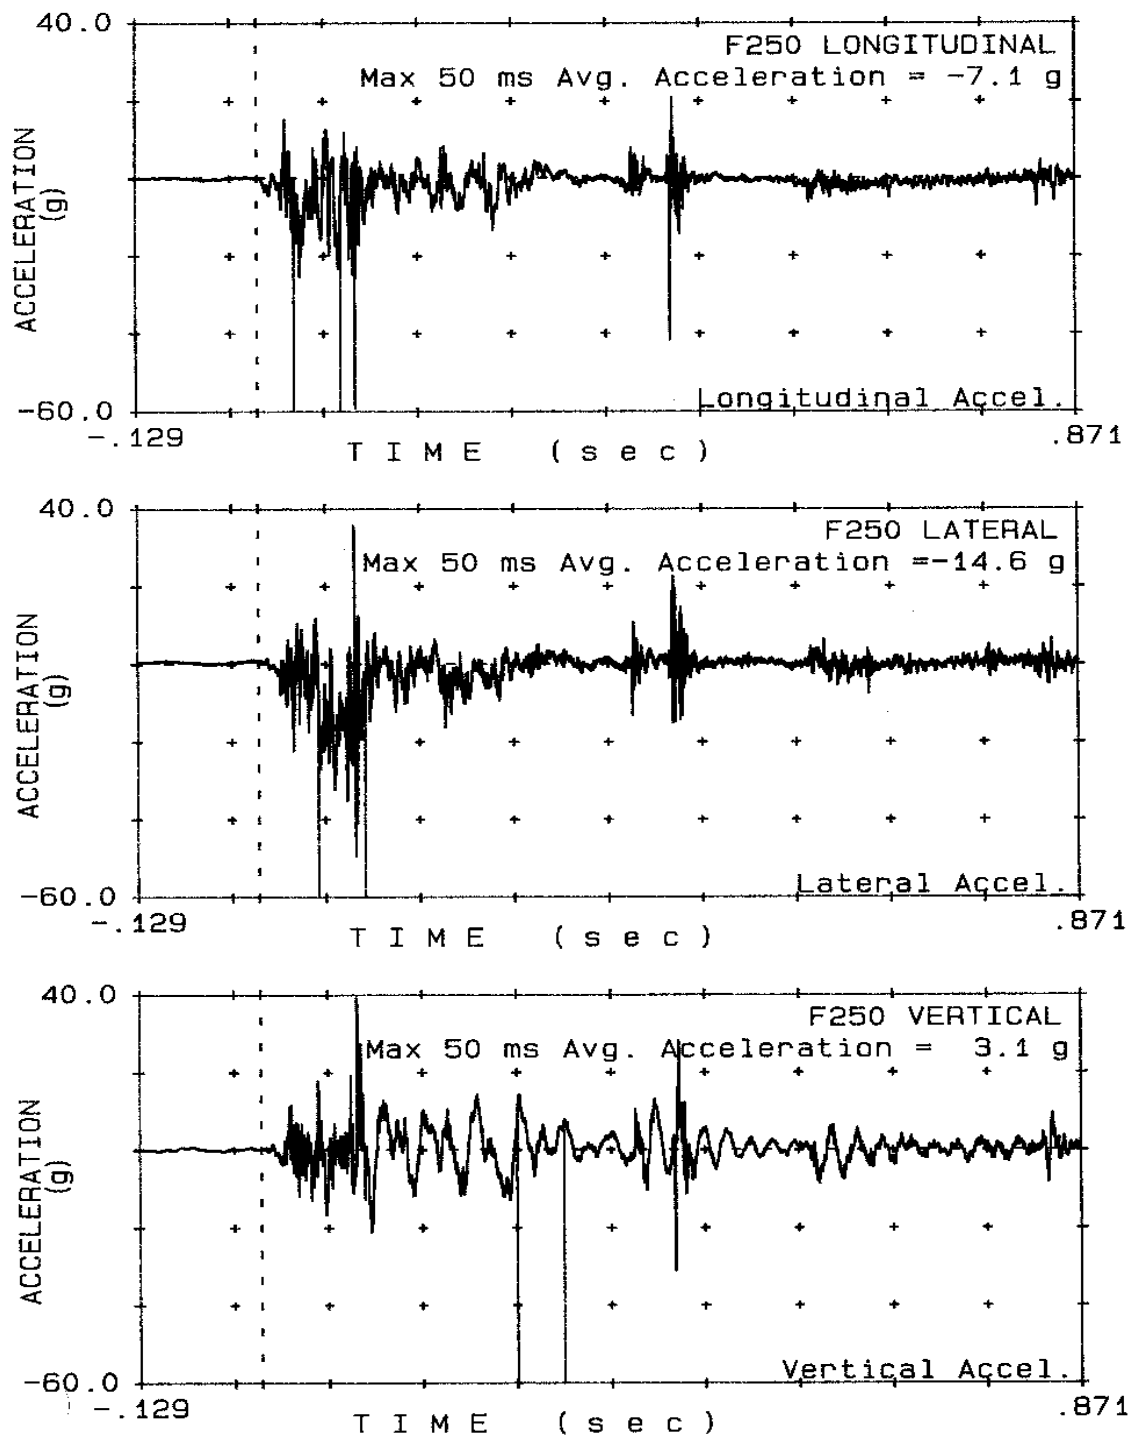
Test #512 Type 70 BR Date: 6/11/97

**Figure 7.9 - Test 512 Vehicle Accelerations -vs- Time**

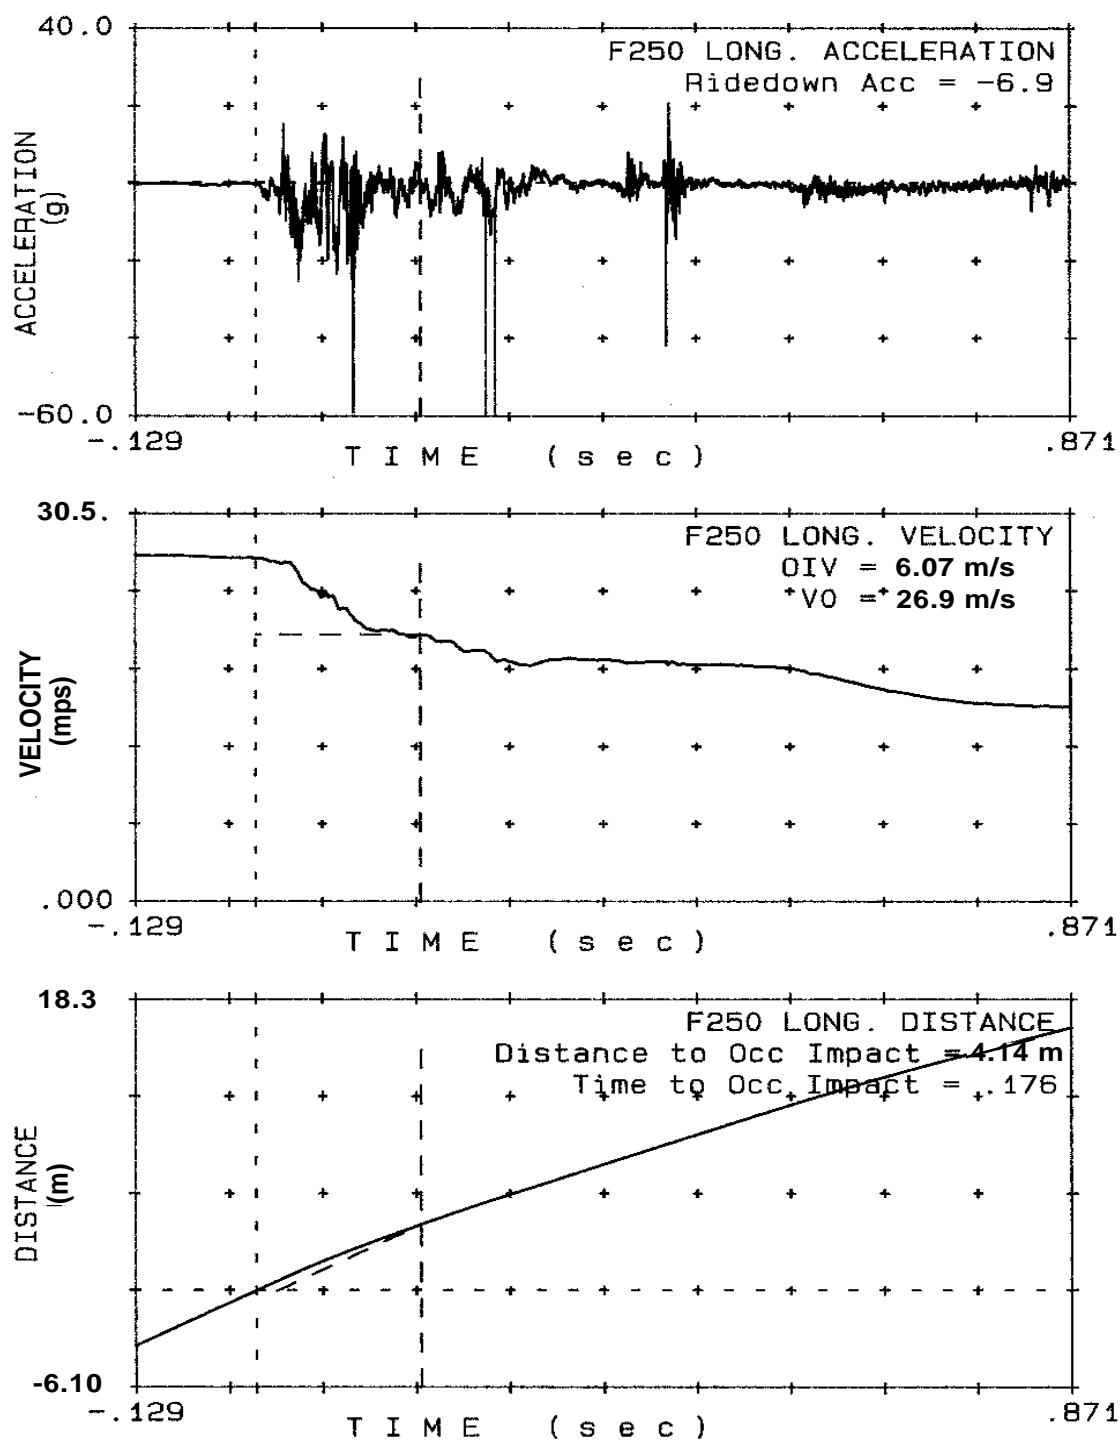
Test #512 Type 70 BR Date: 6/11/97

**Figure 7.10 - Test 512 Vehicle Longitudinal Acceleration, Velocity and Distance -vs- Time**

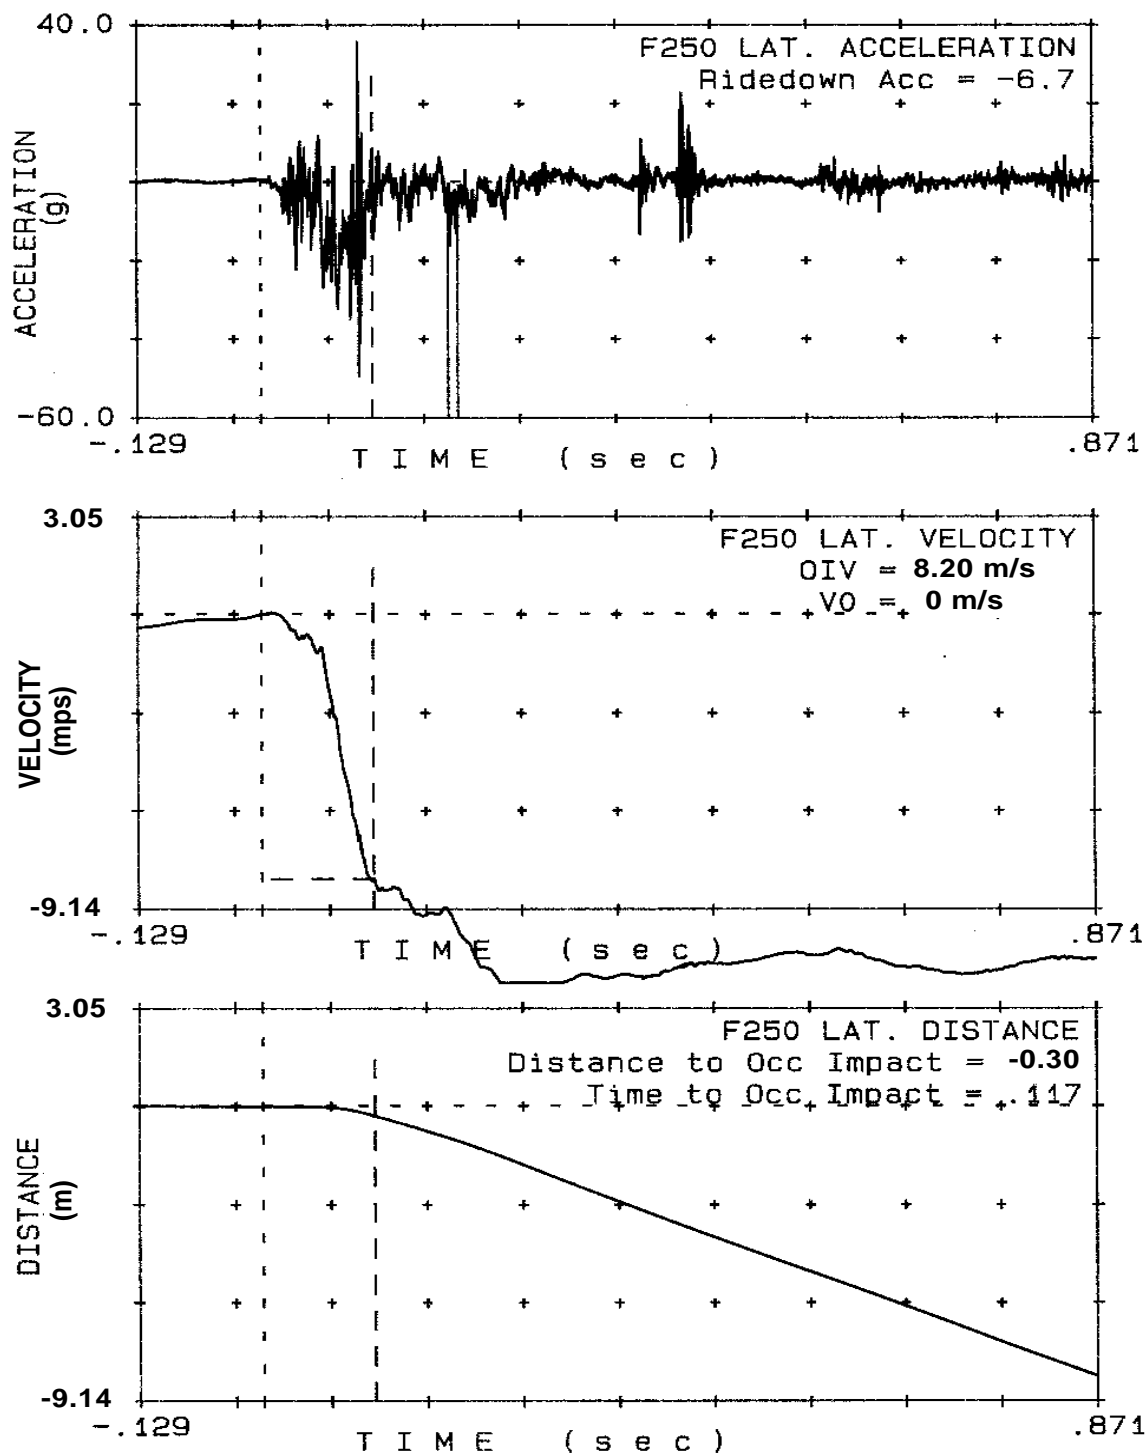
Test #512 Type 70 BR Date: 6/11/97

**Figure 7.11 - Test 512 Vehicle Lateral Acceleration, Velocity and Distance -vs- Time**

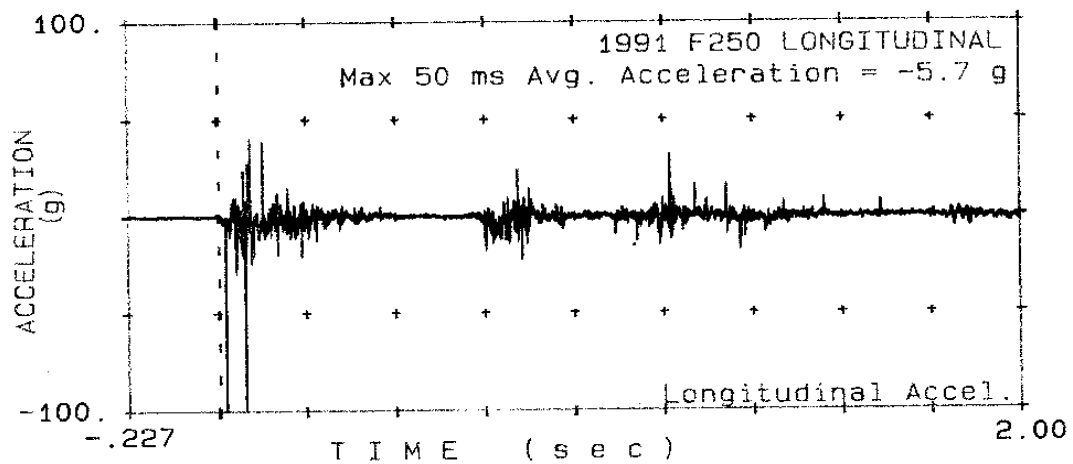
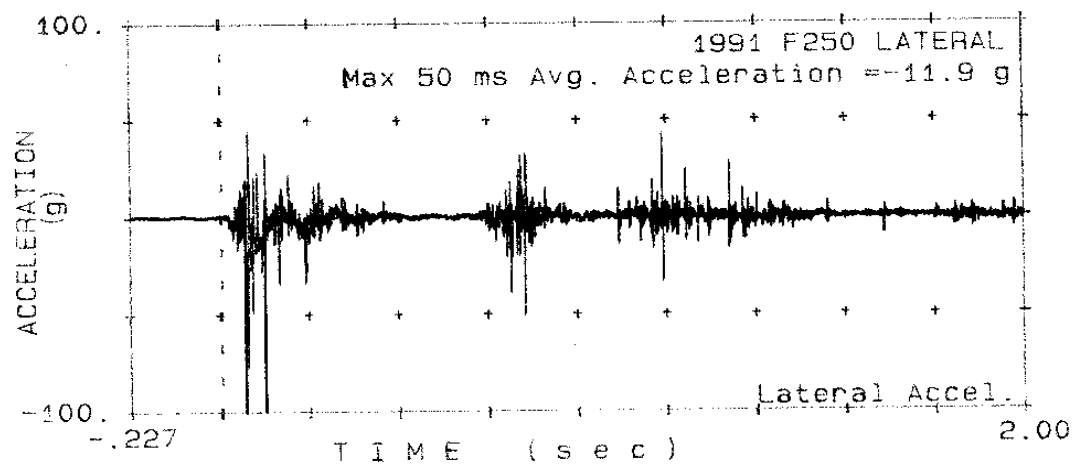
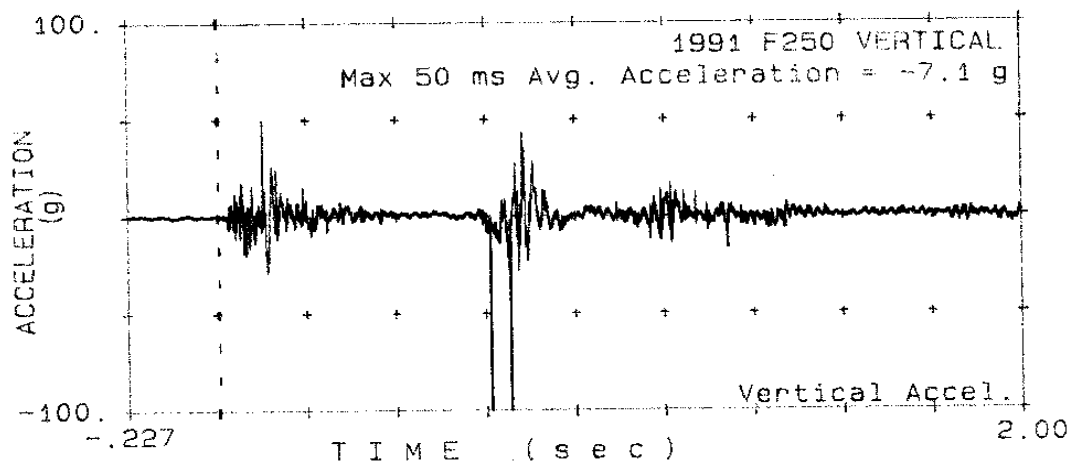
Test #515 TYPE 70 BRIDGE RAI Date: 7/23/97

**Figure 7.12 - Test 515 Vehicle Accelerations -vs- Time**

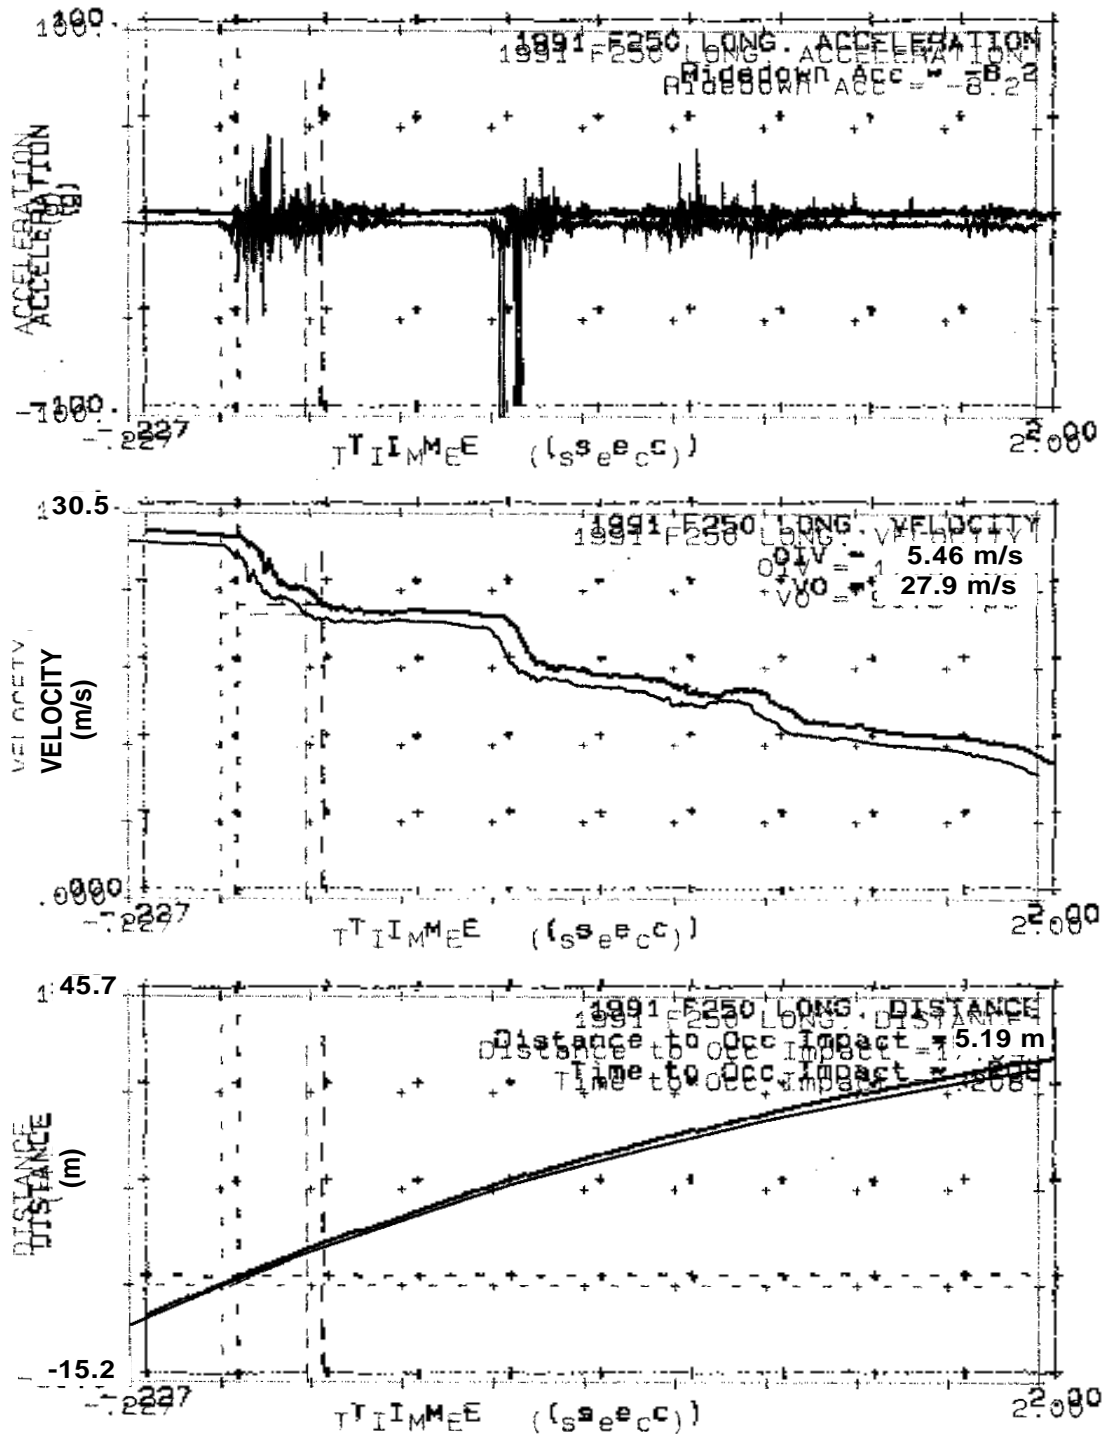
Test #515 TYPE 70 BRIDGE RAI Date: 7/23/97

**Figure 7.13 - Test 515 Vehicle Longitudinal Acceleration, Velocity and Distance -vs- Time**
